## TECHNICAL MEMORANDUM

U.S. NAVAL APPLIED SCIENCE LABORATORY  
NAVAL BASE  
BROOKLYN, NEW YORK 11251

6 IMPROVED PROTECTIVE COATINGS  
FOR  
SONAR DOMES.

9 Lab. Project 9300-43, Technical Memorandum #5

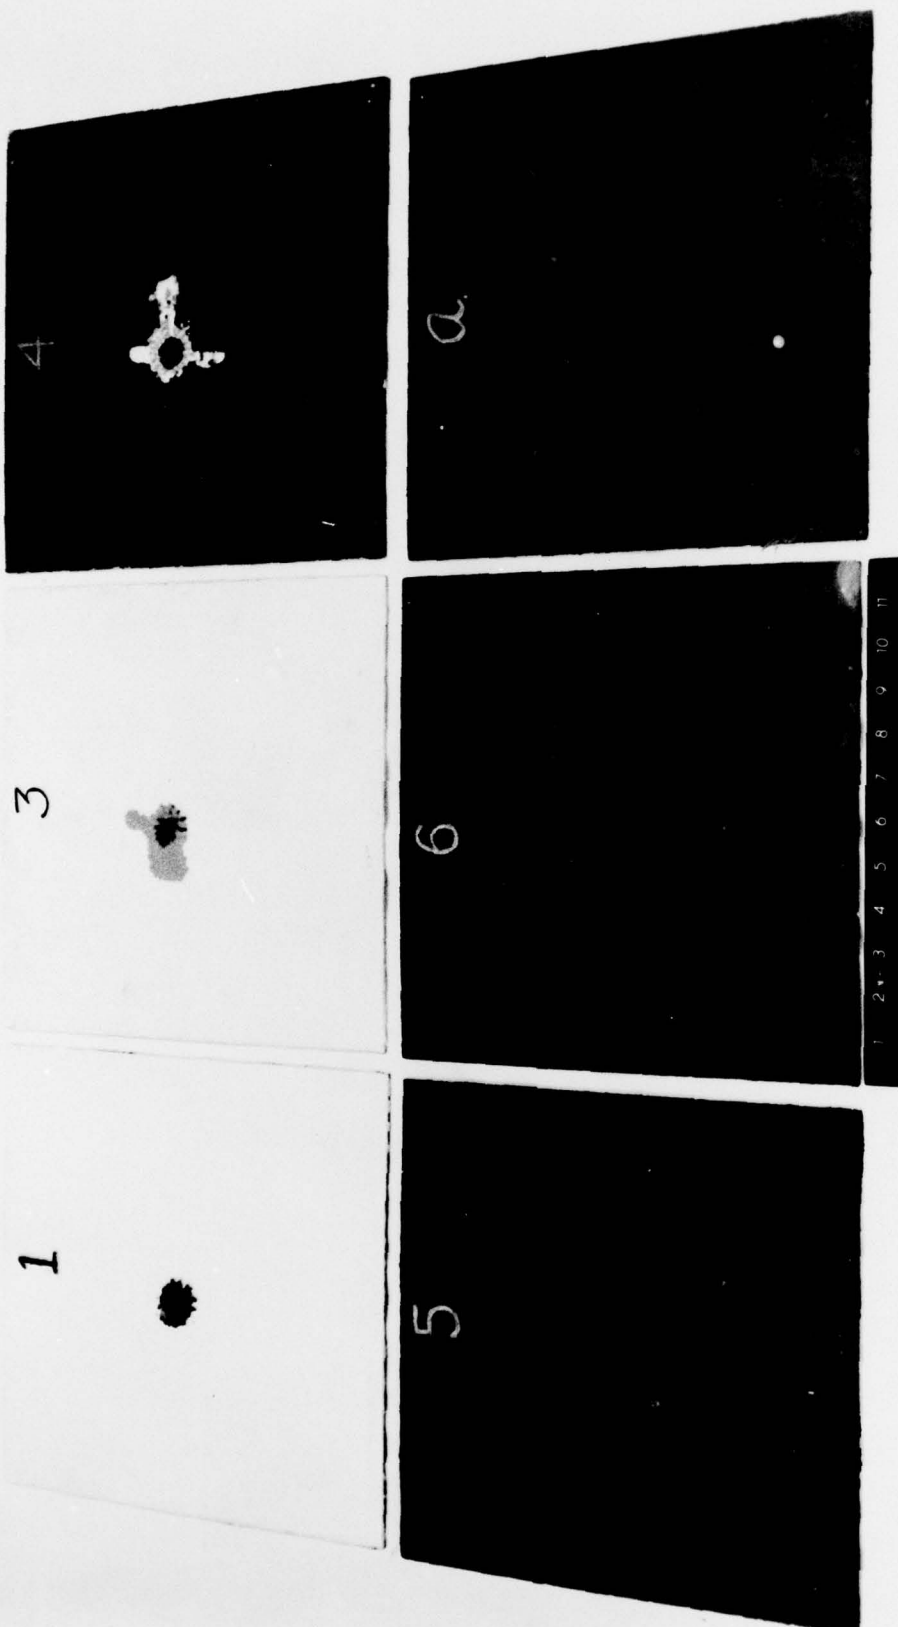
PHOTO L-21081

View showing degree of erosion of experimental sonar dome coating systems.

Incl: (1) Copy of reference (c)  
(2) Table 1 - Results of Sonic Erosion Test  
(3) Photo L-21081, View showing degree of erosion of experimental sonar dome coating systems

4. The results of the tests on the six coating systems are tabulated in Table 1, and the erosion patterns are shown in enclosure (3).

5. The results of tests indicate that with the exception of Panel "a", which is actually a Mare Island Paint Laboratory developed exterior dome coating system used as a control, all the experimental coating systems formulated under the NOBs 90357 contract eroded down to the base metal, and are not considered suitable for use on sonar domes.
